# Vibration analysis of a micro turbojet engine under two impeller structural faults

Yang Z., Ma R., Lei Y., Jia L., Alseiri S., Youssef H., and AlMheiri M. (2026). Vibration analysis of a micro turbojet engine under two impeller structural faults. *Journal of the Global Power and Propulsion Society*. 10: 88–97.  
<https://doi.org/10.33737/jgpps/224659>

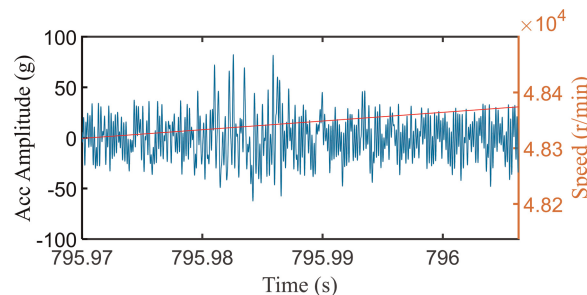
For the case of centrifugal impeller disk fracture, Figure 3 plots the variation of casing vibration acceleration against time, particularly around the fracture event. In this figure, the left vertical axis represents acceleration, while the right vertical axis is the synchronous rotating speed. These vibration data are collected during the speed rise process from 47,500 to 50,000 r/min, as is illustrated by the solid red line. It can be observed that around 795.98 s, the vibration amplitude suddenly increases, whereas before this time the engine appears in a stable vibration state, peaking at approximately 795.982 s. After the peak, the amplitude decreases but remains higher than it was before 795.98 s. Therefore, at the time of 795.98 s, the increment of vibration indicates the occurrence of engine fault.

To further reveal the impact of the disk fracture on the engine vibration characteristics, high-frequency vibration signals were analysed using the previously described analysis procedure. Figure 3 presents the time domain vibration acceleration signal during the disk fracture event. Before the disk fracture (795.97 s <  $t$  < 795.975 s), the engine was operating under normal acceleration state. Due to the initial imbalance of the system, the vibration amplitude remained relatively low. At  $t = 795.98$  s, the amplitude increased sharply. This phenomenon was

Figure 3. Time domain vibration acceleration response for the disk fracture case.

initially identified as an excitation response triggered by the disk fracture. After peaking at  $t = 795.982$  s, the amplitude decreased with the change in rotational speed but remained higher than the pre-fracture level.

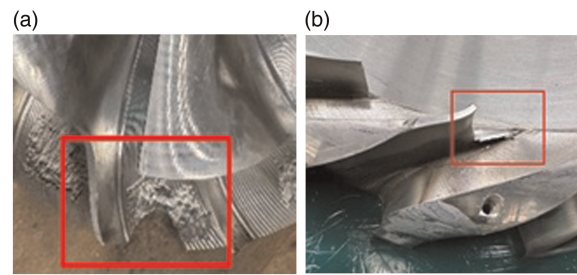
After the test, the engine was disassembled for inspection. It was found that the centrifugal impeller disk had partially fractured, as can be seen in Figure 4a. Furthermore, the radial diffuser blades located after the impeller showed clear rubbing marks and partial fracture, as illustrated in Figure 4b. The structural damage of the diffuser is attributable to the falling part of the impeller disk. Preceding this structural failure, the engine had operated for about 33 h cumulatively. Based on the fault data and the observed component damage, it can be inferred that the failure was caused by structural fatigue, ultimately leading to disk fracture. During prolonged high-speed operation, the centrifugal impeller disk is subjected to significant centrifugal forces and complex aerodynamic forces. These forces continuously act on the disk, causing stress concentration and initiating small cracks at structurally weak points. As the engine speed gradually increases, these cracks propagate further due to cyclic loading. Eventually, the fatigue cracks reach a critical size, leading to disk fracture. The detached fragment is driven by

Figure 4. Disk fracture and radial diffuser damage. (a) disk fracture and (b) radial diffuser damage.

rotational motion and pushed by the flow to move downstream to the diffuser with a remarkably high speed. It then strikes the leading edge of the radial diffuser. The impact results in notches and localized structural damage. It also generates additional vibrational excitation, which further aggravates the dynamic response of the engine.

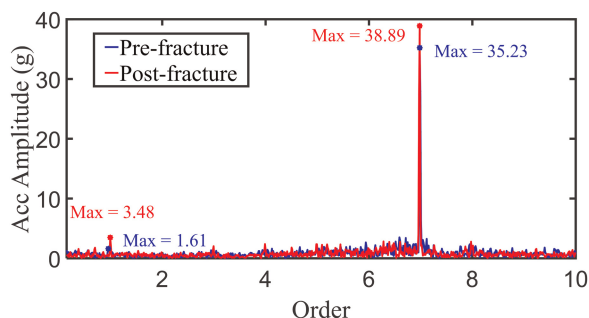
To further identify the vibration characteristics induced by the impeller disk fracture, the order tracking method is utilized to obtain the variation in vibration acceleration before and after the fault occurs. The resulting order spectrums are compared in Figure 5, where the horizontal axis is the order, i.e., the dimensionless vibration frequency normalized by the instantaneous rotational frequency. The solid blue line and the red line represent the acceleration before and after the disk fracture ( $t = 795.98$  s) respectively. Since the centrifugal impeller has seven primary blades, the first 10 order components were compared and analysed. It is evident that before the fracture, the main excitations were the 1st order (RF) and the 7th order (BPF) components. In particular, the vibration at 7X is significantly high. This is a result of the strong aerodynamic excitation force of the BPF acting on the impeller blades. Following the disk fracture, the vibration amplitudes at 1X, 4X and 8X all increased. In contrast, the vibration of the 7X component slightly decreased. These variations indicate that the impeller fracture introduced additional rotor mass imbalance, leading to an increased response at 1X. This result aligns with the findings of (Dang et al., 2021). On the other hand, the aerodynamic force acting on the fractured disk portion was altered, breaking the aerodynamic balance among the seven impeller blades, and resulting in a reduced vibration response at 7X.

Figure 5. Comparison of order spectrums between the vibration before and after the disk fracture.

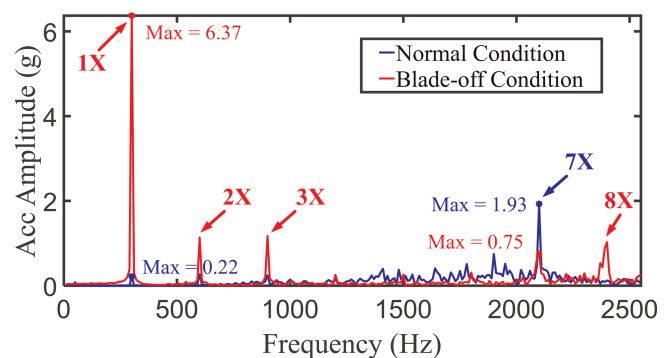
For the steady state, the vibration acceleration spectrums at 18,000 r/min rotational speed are compared in Figure 6 for both normal and fractured conditions, which are respectively denoted by the solid blue and red lines. After the disk fracture, the 1X amplitude increased from 0.24 g under normal conditions to 6.37 g, representing an approximately 28-fold increment. The 7X amplitude decreased from 1.93 to 0.75 g, showing a certain degree of attenuation. The amplitudes of the 2X and 3X harmonic components also increased significantly. This indicates that the fracture disrupted the system's alignment, leading to a rotor system misalignment response. Additionally, modulated frequency components were observed near the 6X and 8X frequencies in the spectrum. These modulations are attributed to the amplitude modulation effect induced by the unbalanced impeller's aerodynamic excitation (Liu, 2024), resulting in modulated sidebands around the BPF. This phenomenon further highlights the significant impact of the disk fault on the aerodynamic and structural coupling characteristics of the system.

Figure 6. Comparison of vibration spectrums between normal and fracture conditions.

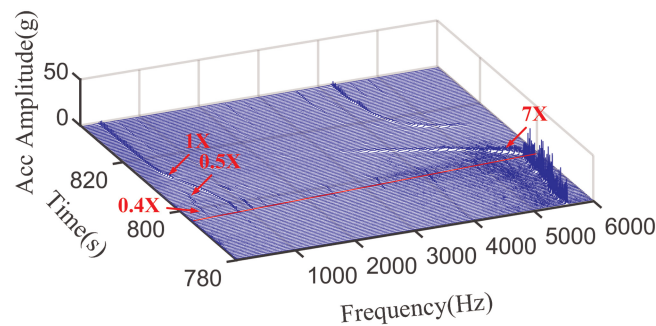
To intuitively observe the dynamic characteristics of frequency components over time, a waterfall plot was generated to illustrate the changes before and after the fault point, as shown in Figure 7. In this figure, the solid red

Figure 7. Waterfall of vibration acceleration during the test.

line marks the test time when the disk fracture occurred. It can be seen that before the disk fracture, the response was mainly dominated by the 7X component. At the moment of fracture, the acceleration amplitude at the 1X component increased sharply, while the 7X component decreased to some extent. As the rotational speed gradually decreased, vibrations at subharmonic components (e.g., 0.4X and 0.5X) were temporarily excited. With a further decrease in rotational speed, the 1X amplitude continued to rise, while the 7X amplitude gradually decreased. Meanwhile, the subharmonic components progressively diminished, and the amplitudes of higher-order harmonics declined dramatically. These changes in vibration frequency and the corresponding amplitude reflect the transient-state characteristics induced by the sudden disk fracture. After approximately 820 s, the vibration response eventually transitioned into a new asymmetric steady state condition.

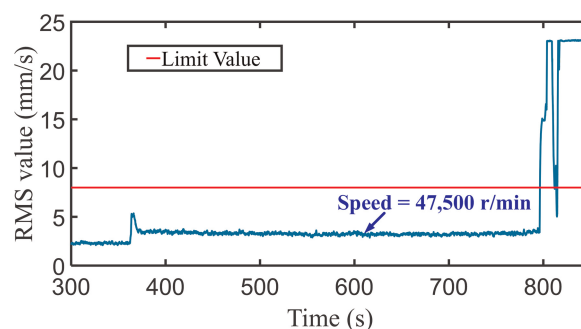
To quantify the impact of disk fracture on the vibration energy of the entire engine, the high-frequency acceleration signals were integrated to obtain the corresponding vibration velocities. The corresponding RMS values at different test times were calculated to reflect vibration severity, as shown in Figure 8, where the solid red horizontal line indicated the velocity limit. The engine operated at 47,500 r/min rotational speed for over 400 s as planned, and the vibration remained stable with an RMS value of about 4.5 mm/s. At 795.98 s (with a corresponding 48,300 r/min rotational speed, as shown in Figure 3), the RMS vibration values increased sharply, exceeding the velocity limit significantly. This is caused by the impeller disk fracture, i.e., the abrupt large amount of mass imbalance.

The detailed RMS values of vibration velocity at different stages are given in Table 2 for both the transient state and the steady state. The former state is taken within a short period just before and after the fault occurs around  $t = 795.98$  s. The steady state corresponds to a stable rotational speed of 18,000 r/min, as illustrated in Figure 7. During the transient stage, vibration severity increased rapidly after the disk fracture. The RMS value reached 321.23% of the pre-fracture level, indicating that the sudden structural failure induces a severe imbalance response in the rotor system, resulting in a transient amplification of the overall engine vibration. For steady state conditions, it is found that the vibration severity of the system after the fracture reached 918.59% of the normal condition. The variation trend of the RMS value is highly consistent with the results from the order spectrum and frequency domain analyses. This consistency further confirms the destructive impact of a disk fracture on the engine.

The engine adopts a 0-2-0 support structure, where both the centrifugal impeller and the turbine can be regarded as cantilever structures. The disk fracture of the centrifugal impeller introduces an unbalanced load at the cantilever end, leading to a deterioration of the system's dynamic balance. Due to the persistent mass

Figure 8. Trend of vibration velocity RMS value along with time.

imbalance and structural asymmetry caused by the disk fracture, the overall vibration level remains consistently high, far exceeding the engine vibration limit.

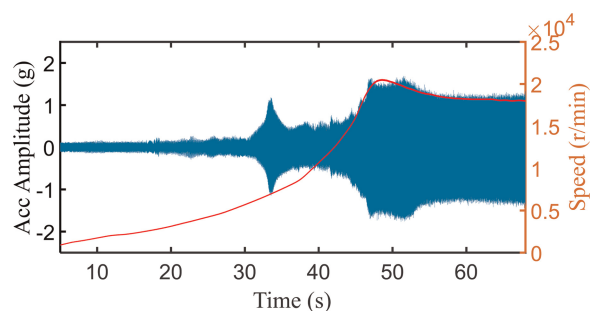
Figure 9 shows the time domain vibration acceleration response under the locking nut loosening condition. After the engine startup, the rotational speed gradually increased. At 30 s, the vibration acceleration amplitude exhibited a sudden abnormal increase. This suggests that the locking nut had significantly loosened at that moment, causing unbalanced excitation in the rotor system. The vibration amplitude peaked at approximately 33 s during the startup phase and then slightly decreased. As the rotational speed continued to increase, the vibration amplitude increased again and eventually stabilized at a steady state under the fault condition. This phenomenon indicates that the locking nut loosening fault has a sustained impact on the system vibration, and the extent of loosening directly influences the intensity of the system response.

Figure 9. Time-domain vibration acceleration response for the locking nut loosening case.

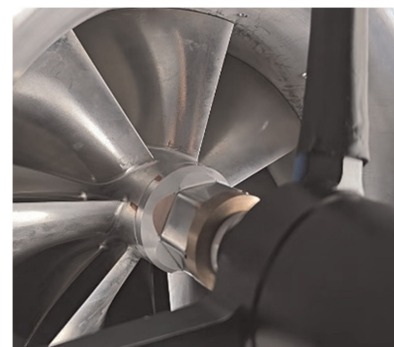
The engine was inspected after ruling out sensor malfunctions, revealing significant loosening of the centrifugal impeller locking nut as shown in Figure 10. The engine had accumulated approximately 60 h of operation and had undergone two overhauls. It is inferred that this failure represents a typical shaft-nut fit failure. Due to frequent engine overhauls and prolonged operation at medium to high rotational speeds, the interference fit between the nut and the shaft gradually loosened, ultimately resulting in the failure of the locking function.

Figure 10. Loosening of the centrifugal impeller locking nut.

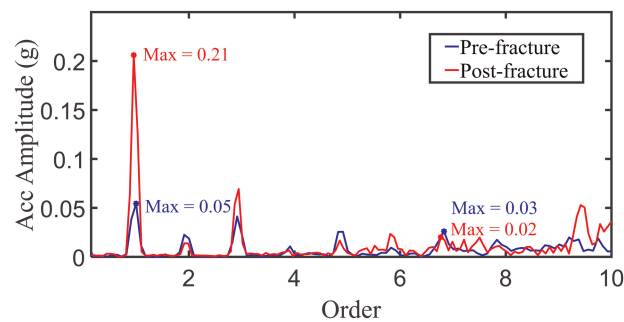
Figure 11 shows the comparison of the order components before and after the occurrence of the locking nut loosening fault. Before the fault occurred, the system exhibited minor 1st, 2nd, and 3rd order responses, mainly due to the initial imbalance and slight misalignment. After the loosening of the locking nut, the amplitudes of the 1st and 3rd orders increased significantly, while the 2nd and 7th order components remained relatively unchanged. This suggests that the loosening of the locking nut changed the rotor assembly alignment, leading to an unbalanced system response and compromising the alignment. The rotor support also became misaligned, introducing additional nonlinear stiffness (Liu et al., 2017). Since this fault primarily originates from structural fit loosening rather than aerodynamic excitation, the 7th order component remained stable.

Figure 11. Comparison of order spectrums between the vibration before and after the fracture.

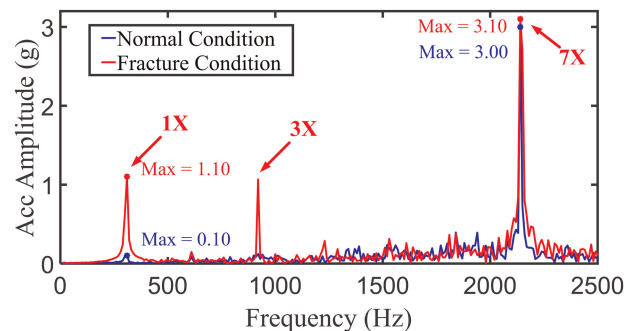
Figure 12 presents the frequency spectrum comparison between the fault condition and the normal condition at 18,000 r/min steady state speed. The results of the frequency domain analysis are consistent with the order spectrum, revealing a significant increase in the amplitudes of the 1X and 3X components, while the 7X component remains relatively unchanged. It is worth noting that although the 7X amplitude did not increase due to

Figure 12. Comparison of vibration spectrums between normal and nut loosening conditions.

the loosening fault, it is still higher than other harmonic components. This indicates that the BPF amplitude is primarily influenced by the aerodynamic excitation caused by the increase in rotational speed, rather than being directly related to the loosening fault.

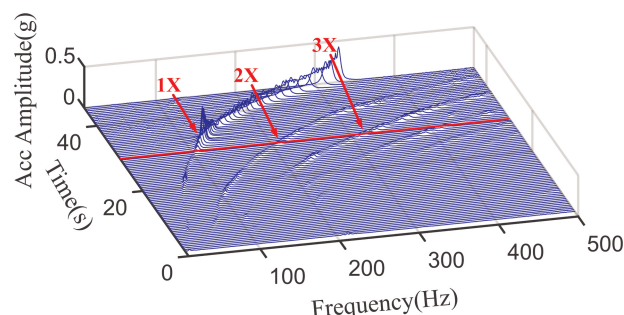
Figure 13 illustrates the waterfall plot of the startup phase under the locking nut loosening fault conditions. Before the occurrence of nut loosening, the amplitudes of the fundamental and lower harmonics were relatively small. At approximately 33 s, the locking nut loosening intensified, causing the 1X amplitude to rise rapidly. As the rotational speed continued to increase, the 3X amplitude exhibited a continuous growth. Eventually, the system stabilized in an unbalanced and misaligned state caused by the loosening fault.

Figure 13. Waterfall of vibration acceleration during the loosening fault test.

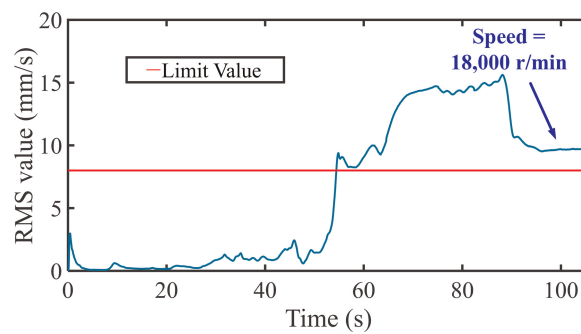
The corresponding RMS values at different test times were calculated to reflect vibration severity, as shown in Figure 14. Following a successful startup, the rotational speed was increased to 18,000 r/min and the values exceeded the limit. The RMS values for different operational stages are summarized in Table 3. The results indicate that during the transient stage, the RMS value after the loosening fault is 1.2 times higher than that of the pre-fault condition, indicating that the loosening of the locking nut exacerbates the unbalanced vibration response. At 18,000 r/min steady state speed, the RMS value under fault conditions is three times higher than that in the normal condition.

This indicates that the fault not only causes a short-term increase in excitation but also leads to the system maintaining a high vibration level over a prolonged period.

Figure 14. Trend of vibration velocity RMS value along with time for nut loosening test.
