# Accelerated thermal profiling of gas turbine components using luminescent thermal history paints

thermal history paint; temperature measurement; luminescence; nozzle guide vanes

Araguás Rodríguez S., Jelínek T., Michálek J., Yáñez González Á., Schulte F., et al. (2018). Accelerated thermal profiling of gas turbine components using luminescent thermal history paints. *Journal of the Global Power and Propulsion Society*. 2: 344–361. <https://doi.org/10.22261/JGPPS.S3KTGK>

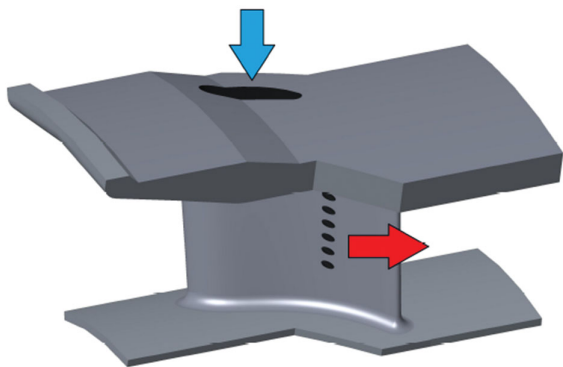
Figure 1. A proposed concept of the NGV cooling.

The cooling air (*blue arrow*) enters the inner vane cavity and then is discharged through few cylindrical holes into the pressure side boundary layer (*red arrow*) thus forming a protective film on a portion of the vane surface downstream.

These constraints resulted in a simple concept of active fluid cooling with an internal vane cavity vented through seven cylindrical holes to the pressure side boundary layer, as shown in [Figure 1](#). The cavity was to be supplied by the compressed air from the space between the CC and the outer diameter of the NGV shroud. Such a solution, however, required a redesign of the vane profile. Details about the redesign and the new geometry are addressed in the following section.

Two main effects were expected from the proposed cooling arrangement: a) heat transfer from the vane due to convection of air through the cavity and b) partial protection of the trailing edge region due to a film forming downstream the cooling holes.

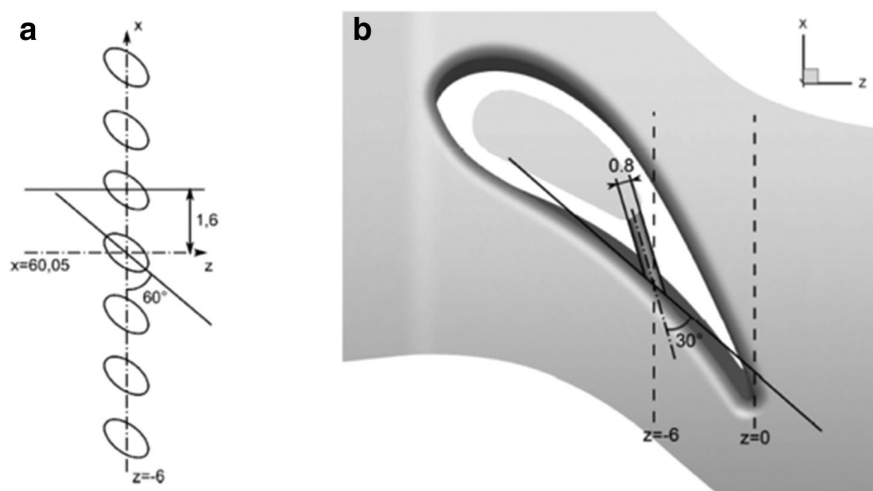
Figure 2. Geometry of the vane cooling channels: Meridional plane (a), tangential plane (b).

The tested cooling system consists of an oval shaped cavity, which goes through the thickest part of the vane and opens into an annular channel next to the shroud. Cold compressed air flows through this channel and is diverted before reaching the CC, which serves as a cooling medium. This cold air is brought from inside of the cavity to the surface of the pressure side of the vane by seven cylindrical holes. These holes are parallel to each other; each of them has a diameter of 0.8 mm and spaced two diameters apart. The central hole is positioned slightly above the mean radius of the wheel and the openings are located on the surface about one third of the vane from the trailing edge. The cooling channels were designed such that the middle one is inclined of 30° with respect to a tangent to the surface. The axes of the coolant channels are also tilted with respect to the

machine axis with a compound angle of 30°. The configuration of the cooling channels is presented in Figure 2.

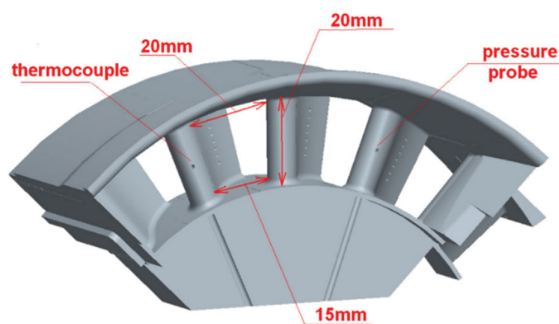
Figure 3. Segment with internally delivered coolant – NGV-IC.

Only the NGV-IC was selected for the use with THPs. The NGV-IC variant, shown in Figure 3 represented a real engine configuration with three hollow vanes and seven cooling holes deployed on the pressure side of each vane. The variant utilized the coolant (mostly compressed air) from a space between the CC and the outer diameter of the NGV wheel. The cooling air was then returned back to the main flow through the cooling holes. The mass flow rate of the coolant was given by prescribed flow parameters and by an effective flow area of the cooling holes. The amount of the coolant was not measured directly.

A total pressure reading (P01) was performed by means of a stainless-steel tube of 1.2 mm inserted into a channel along the leading edge. It was again fixed inside the cavity by the high temperature cement. The tube end was connected to the medium through a drilled opening (0.8 mm) close to the stagnation point at the vane mid-height, see Figure 3. The cavity opening was not shielded.

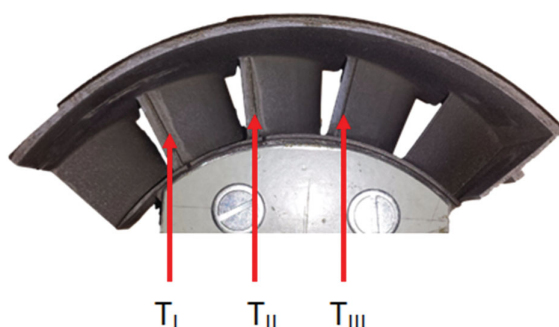
Figure 4. NGV-IC segment showing the location of the three thermocouples T<sub>I</sub>, T<sub>II</sub> and T<sub>III</sub>.

A shielded K-type thermocouple intended for measuring the total temperature (T0) of the exhaust gas was inserted into a channel prefabricated along one of the vane leading edges and fixed by a high-temperature resistant cement (Omega CC type), see Figure 3. The sensing end of the thermocouple was positioned at vane mid-height and connected with the hot gases through a drilled

hole of 0.8 mm located in the vicinity of the stagnation point. The cavity of the probe was not ventilated.

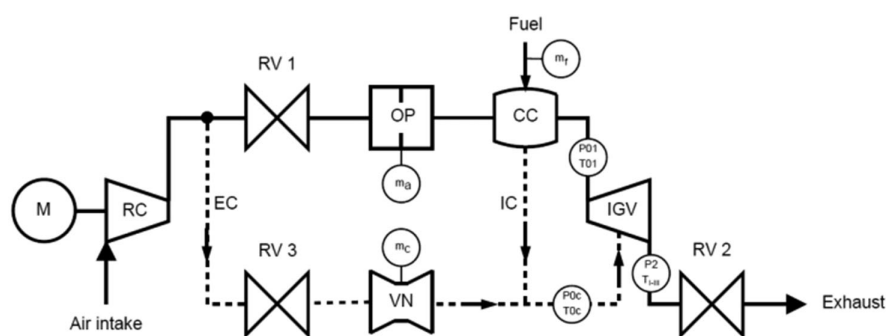
Figure 5. A scheme of the test rig with two alternative cooling arrangements.

The test rig comprised three principal parts: a radial compressor (RC), a CC and the tested NGV segment. The amount of air supplied by the RC at the desired pressure was restricted by its working regime and, therefore, only a quarter segment of the CC was considered in the test rig.

The desired mass flow and pressure ratios were achieved through the control of a compressor working regime and via two regulating valves RV1 and RV2 placed behind the compressors and NGV, respectively. An actual air mass flow rate delivered by the RC was measured by a calibrated orifice plate (OP) located before the CC. An entire amount of the mass flow rate across the NGV

was thus given by a sum of the air and fuel mass flow rates. A scheme of the test rig with alternative cooling arrangements supplied with measured parameters is presented in Figure 5.

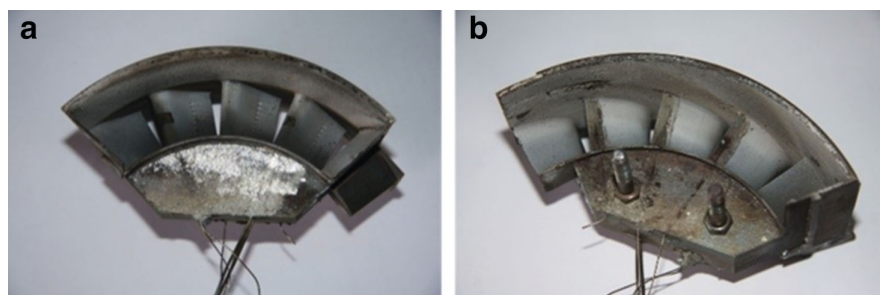
Figure 6. The (a) front view and (b) back view of the NGV segment after testing.

The paint is adherent at all locations.

The paint remained adherent at all locations on the component. A photograph of the component after testing is shown in Figure 6. As expected, some colour variation was observed due to the thermal exposure. The colour variations provide an initial estimate of the temperature profile over the component. Darker areas, as seen at the base of the NGVs, indicate higher temperatures. Lighter areas, as seen on the shroud, indicate lower temperatures.

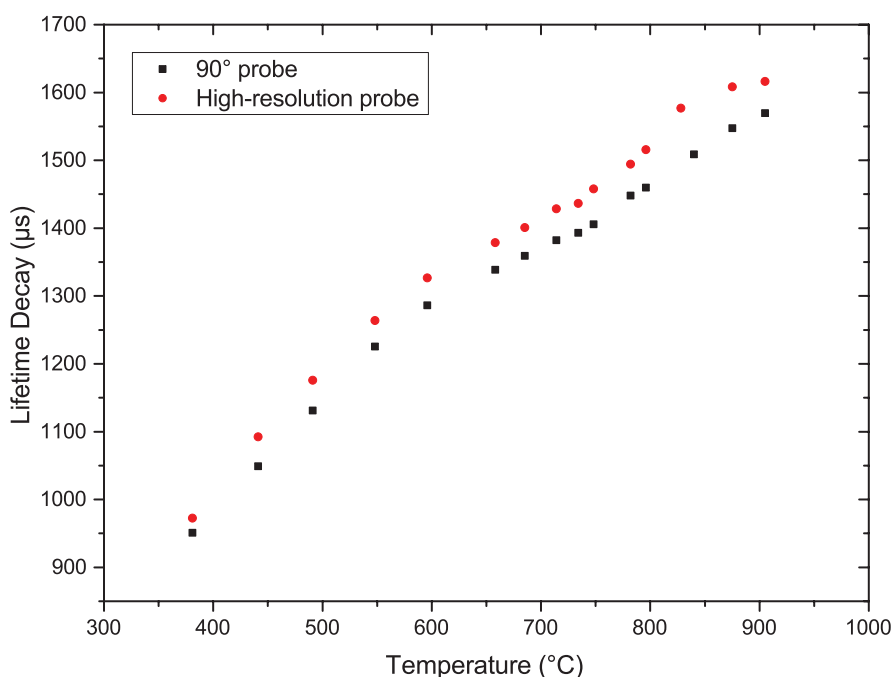
Figure 7. The calibration data recorded from the samples. Different plots show the results from the two different probe types.

Each sample was used to construct one data point in the calibration curve, relating a particular temperature of exposure to the corresponding lifetime decay. Five repeat measurements were carried out per location. Two different probes were used to make the measurements on the NGV segment to overcome the limited access to the painted surfaces. The results of the calibration are plotted in Figure 7. The plots show the same trend, however there was an offset due to the different settings used for the different probe types. The calibration curve constructed was used to convert the measured lifetime decay values on the components into the corresponding temperature values. A linear interpolation between each neighbouring point pair was used in order to cover the full temperature range.

A single sample received the same heat treatment. The variation in measured temperature over each sample, therefore, gives an indication of the precision of the measurement. Two samples were measured at five different locations with five repeat measurements at each location. The standard deviation of all 25 measurements was used to estimate the precision of the temperature measurement. The estimated precision across the entire temperature range was below  $\pm 5^{\circ}\text{C}$ .

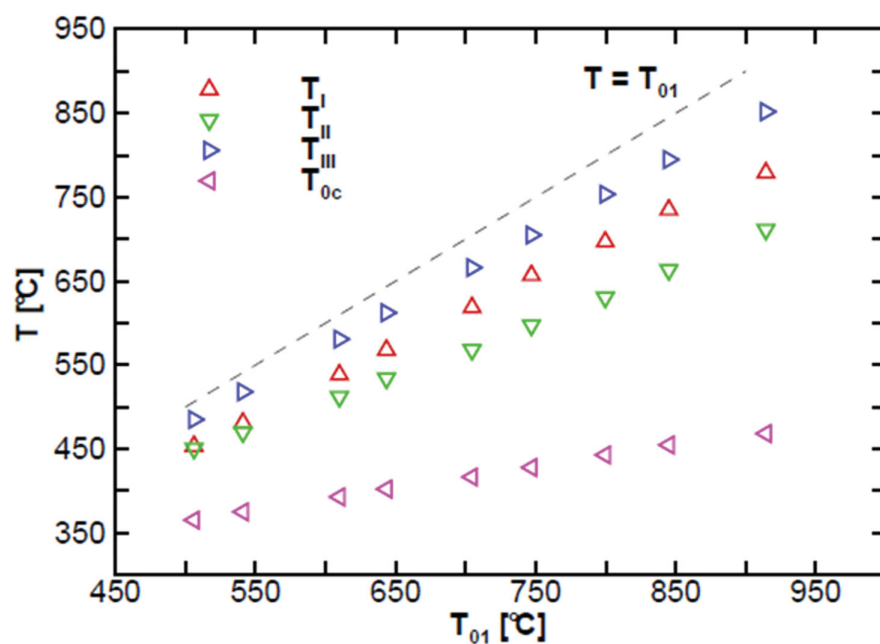
Figure 8. An evolution of the blade metal as a function of  $T_{01}$  during a setup test.

A number of preliminary tests were carried out with the NGV test rig setup outlined above. Typical metal temperature readings are shown in Figure 8. The primary vane regime can be described by a number of parameters. These are inlet temperature  $T_0 = 850^\circ\text{C}$ , total inlet pressure  $P_{01} = 476\,481\text{ Pa}$  and by pressure drop:  $P_2/P_{01} = 0.557$  ( $M_{2is} \approx 1$ ). The resulting thermocouple data is shown in Figure 9. The vanes show significantly different readings, which will be discussed later.

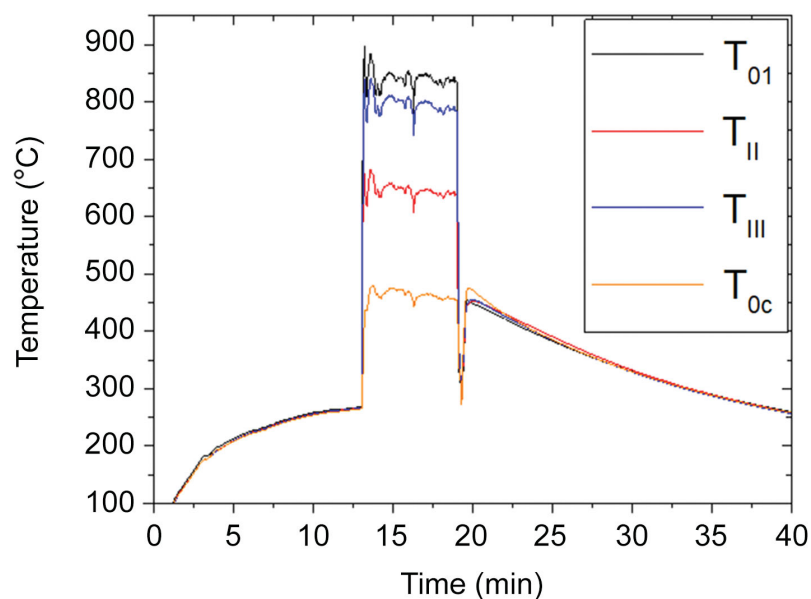
Figure 9. Thermocouple data as function of THP test time.

The estimated time at temperature is approximately 6 min.

During the THP testing an unexpected fault resulted in lower pressure and Mach numbers than expected.  $T_I$  could not be measured due to damage during the handling and coating application. The remaining thermocouple traces as a function of time are shown in Figure 9 (for probe locations see Figure 4). An approximately steady state regime was achieved for all thermocouples for 6 minutes, between 13 min and 19 min from the start of the test.

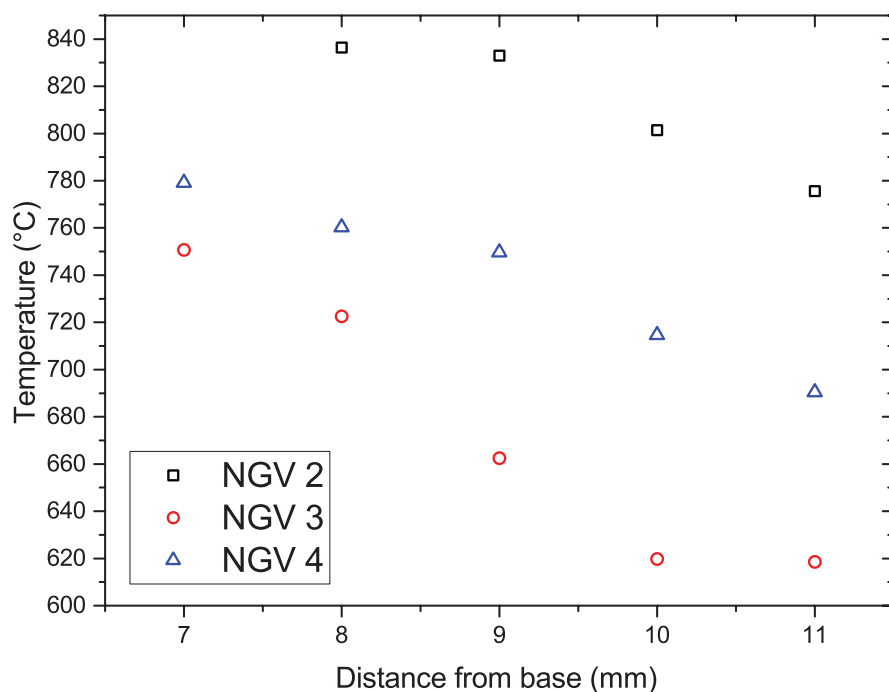
Figure 10. The temperature measurements from the THP on the pressure side trailing edges of the three cooled NGVs (Line 6 in Figure 10).

For further comparison, the results from THP at the trailing edges of the three NGVs with cooling holes are plotted in Figure 11. The plot shows the temperature profile was similar on all NGVs however the absolute temperature was different.

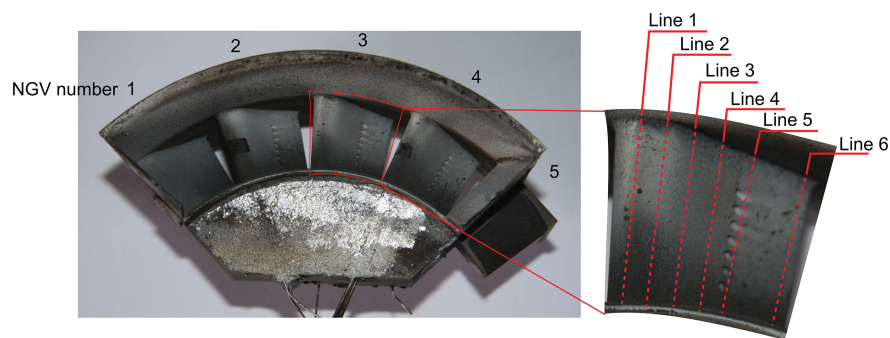
Figure 11. The NGV segment showing the number assignment to each NGV and the six different measurement lines.

On the pressure side, each NGV was measured individually along six measurement lines as shown in Figure 10.

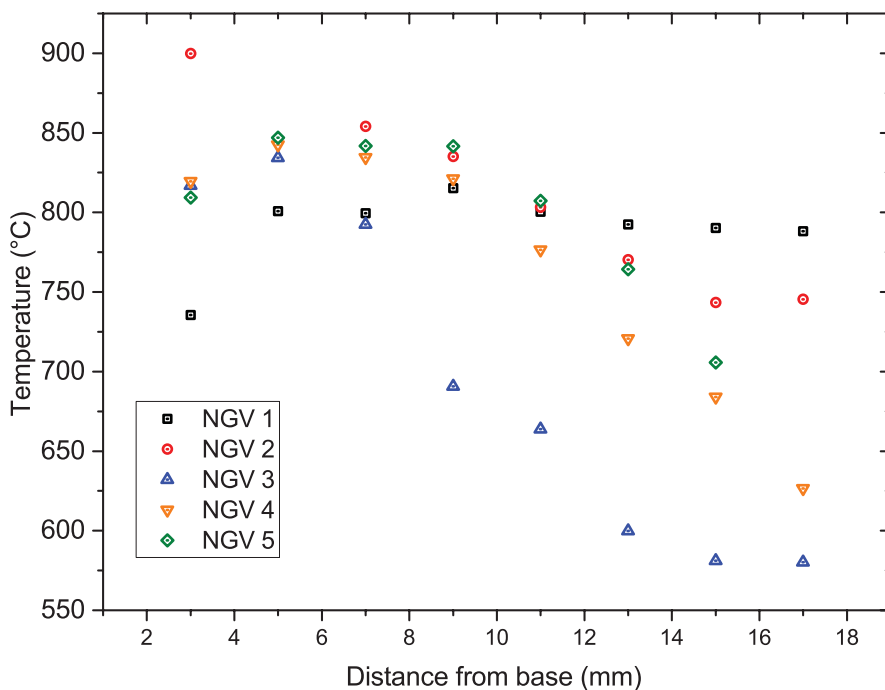
Figure 12. The temperature measurements along a line adjacent to the thermocouple on the suction side of all NGVs.

As in the pressure side, the mean temperature measured with the THP on the three cooled NGVs indicates NGV 2 was hottest, NGV 3 coolest and NGV 4 was intermediate. These results are consistent with the differences in temperature measured by the thermocouples at the trailing edges. The results from the THP along a line adjacent to the thermocouple on all NGVs are plotted in Figure 12 for a further comparison. The plot shows the temperature profile was similar on all NGVs except NGV 1. This observation may be expected because of the different boundary conditions and geometry of NGV 1 compared to the other NGVs. The temperature decreased towards the shroud on NGV 2–5. The absolute temperature of the NGVs was different as stated earlier. The plot shows that NGV 3 was clearly cooler than the others, and NGV 2 was generally hotter than the rest.

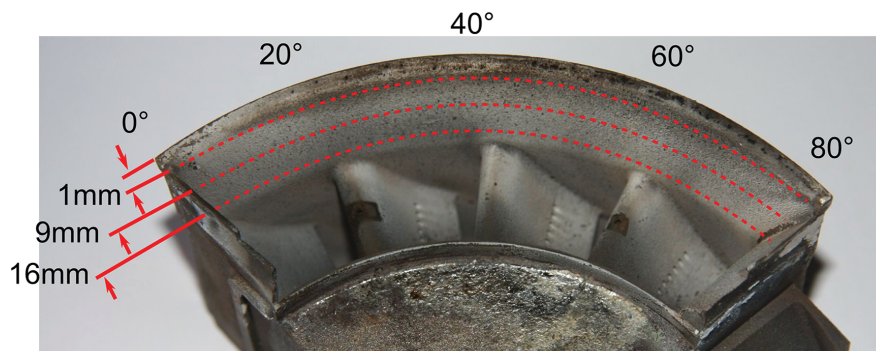
Figure 13. The location of the measurement lines on the shroud upstream.

Measurements were recorded on the THP along three measurement lines as indicated in Figure 13. A measurement was taken every 5° around the circumference of the shroud. The results of the measurements are plotted in Figure 14. The temperature profile across all three measurement lines was similar. The temperature decreased from the left side and the temperature gradient appears to be similar. The temperature increased towards the leading edge of the NGVs. The temperature difference varied between 31°C and 120°C. Furthermore, the temperature increased by 30°C–50°C towards the right side (80°) on all measurement lines.

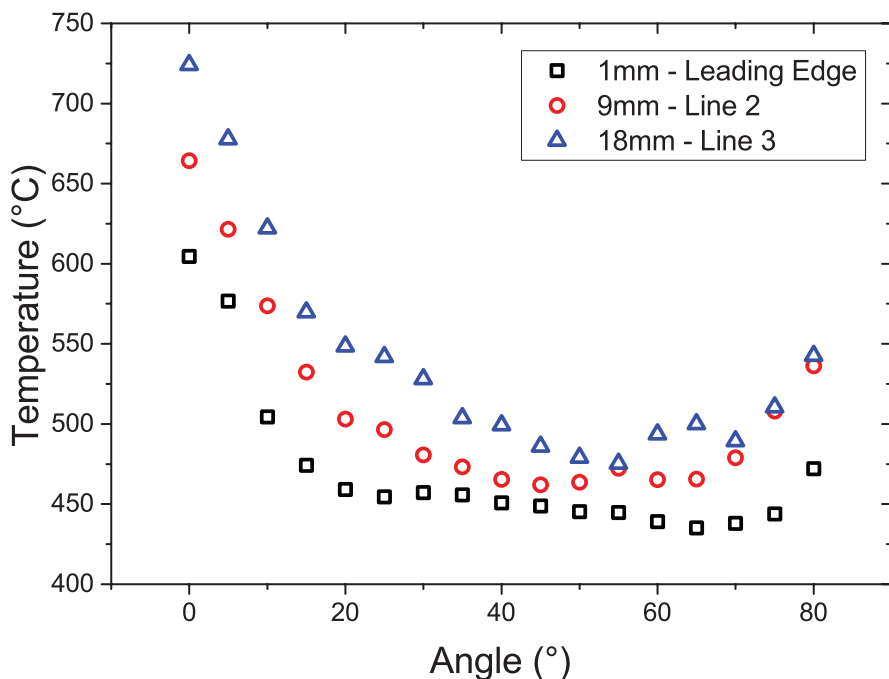
Figure 14. The temperature measurements on the shroud upstream at the three different measurement lines as shown in Figure 13.

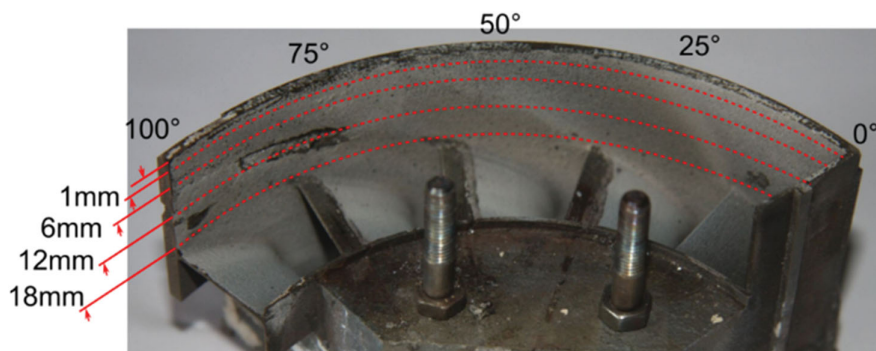
Figure 15. The location of the measurement lines on the shroud downstream.

The shroud downstream was measured along four measurement lines, shown in Figure 15. A measurement was taken every 5° around the circumference of the shroud. The notation of the angles is anti-clockwise to match the angular values to the shroud upstream.

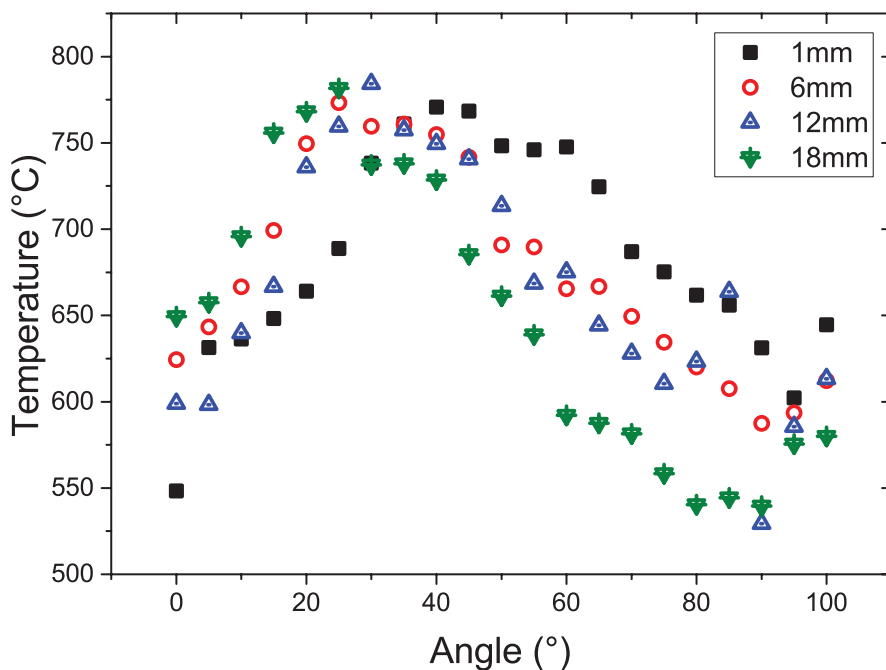
Figure 16. The temperature measurements on the shroud downstream at the four different measurement lines.

The results of the measurements on the shroud downstream are plotted in Figure 16. The figure shows that the temperature increased on all measurement lines to a maximum at a rotational angle of 20–40°. This indicated that there was a band of higher temperature across the shroud surface.

The temperature variation was greater closer to the NGVs. All measurement lines follow a similar trend, except the line at 12 mm between 80° and 95°. At this location there was a wide fluctuation in the temperature measurements in a short space. Here the measurements were made at the repair on the component, therefore, there was a different substrate material. The change in material may be the cause of this fluctuation in the temperature measurements, either due a change in temperature due to the different material or due to an interaction between the paint and the substrate material.

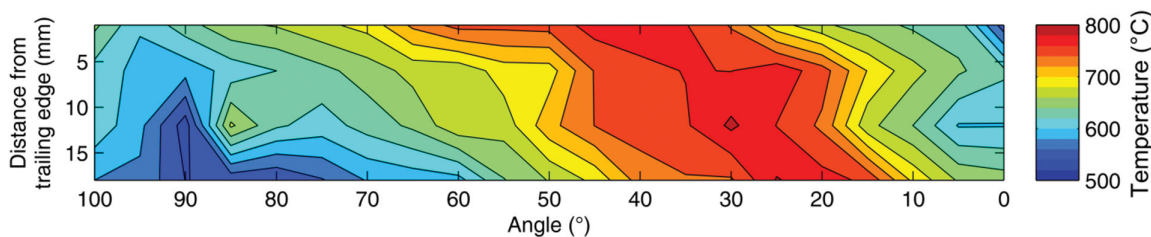
Figure 17. The temperature measurements on the shroud downstream represented as a contour plot where the contours are at every 20°C.

The results plotted in Figure 13 are represented as a contour plot in Figure 17. The plot clearly shows the temperature variation over the surface of the shroud downstream. The figure clearly shows a higher temperature region which corresponds to the gas stream exiting between NGV 1 and 2. This observation indicates the gas stream was hotter over NGV 2, which correlates to the

temperature measurements on the pressure and suction side of the NGVs. This thermal map demonstrates the capabilities of THPs, which enabled the generation of a detailed temperature map across the component surface over quite a small area. The results shown agree with observations made of both the pressure and suction side. While they reveal the same trend as the thermocouples (*i.e.*, NGV2 was the hottest), these results expand on that information and accurately reveal the precise gas stream path.
